**Christ Church
Shelton & Oxon**

**Quinquennial Inspection
Report**

March 2017

CHRIST CHURCH, SHELTON & OXON 2017 QUINQUENNIAL REPORT

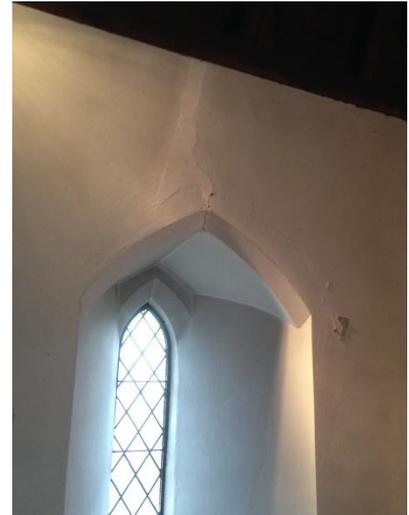
Internally, there are hairline cracks above and below north & south windows, noted in the previous reports, which are thought to mainly relate to thermal movement. Some of the cracks have slight bulging either side, which suggests they open and close seasonally. This can sometimes be caused by wetting and drying of the ground due to drainage problems, so it is important to ensure drainage gullies continue to be checked and cleared regularly.

The cracks above the western windows on the north side of the nave are slightly more pronounced. This is thought to have been caused by poor drainage, which has now been addressed.

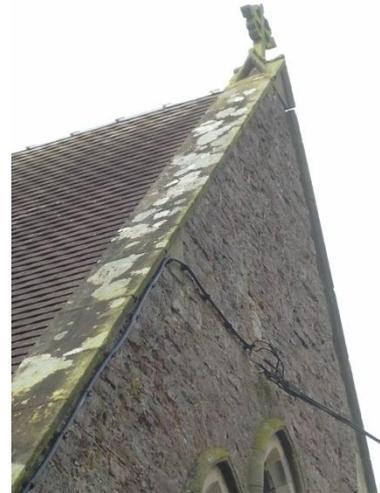
Since the last report, open joints and loose kneeler stones on the vestry gable have been repointed. There are, however, still open joints below here and also between copings to chancel and organ chamber gables, which need to be repointed before water ingress causes damage.

The crosses on the tops of gables lean inwards slightly. This was noted in the previous reports (photos have been taken using a drone) and is not an immediate cause for concern. There is, however, cracking below the cross on the east end, which could indicate it is coming loose, and this should be checked and repaired when the copings are repointed.

- Re-point copings to the chancel and organ chamber gables
- Check and re-fix the gable cross on the east end
- Re-point open joints to the vestry north gable wall
- Repair bottom of vestry door frame

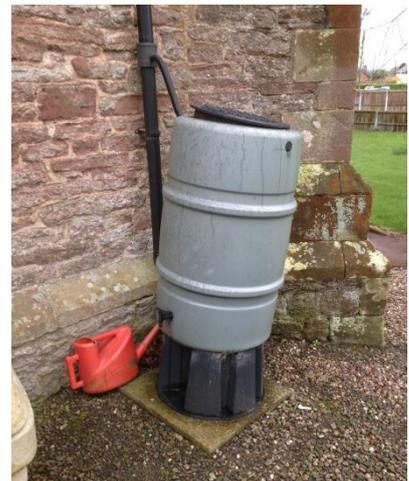
Since 2012, the drain at the northwest corner has been uncovered and the downpipe connected into it, with a feeder pipe to a water butt. The butt isn't level and the valve on the feeder pipe doesn't always work. This needs to be corrected, by levelling the butt and possibly replacing the valve, so water doesn't overflow into the ground. It is also worth considering reconfiguring the bottom of the downpipe so it feeds over a grille into the gully (the same as the others) rather than feeding any debris direct into the drain.

- Check and clear gutters and downpipes (annually)
- Clear the hidden valleys to transept roofs (annually)
- Check and clear all drainage gullies (annually)
- Check condition of gravestones and trees (annually)
- Check & clear paths (at least annually)
- Level the water-butt and ensure it doesn't overflow

- Reconfigure downpipe at n.w. corner to feed into a gully
- Repair or replace fencing to northern part of west boundary
- Consider re-fixing or moving some gravestones that are laid flat

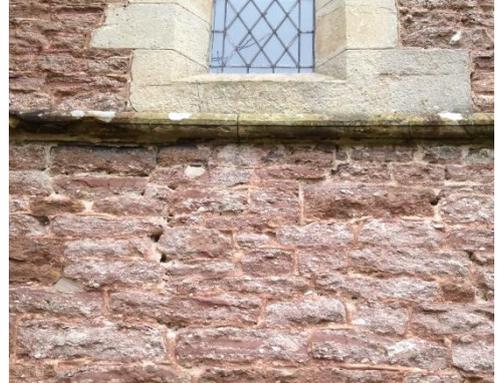
Stonework on the west end also has a few open joints that it would be best to repoint/fill, to prevent water ingress or erosion. The previous report noted cracking in some of the hood mould stones over the two lancet windows on this end. These stones have been replaced and the hood moulds are now in a good condition.

- Re-point open joints to the west end
- Check condition of statue on west end, and repair as necessary
- Paint and gild the clock face on the west end
- Re-lead the vestry east window and fit better protection
- Carry out localised repairs to other windows and repaint ferramenta

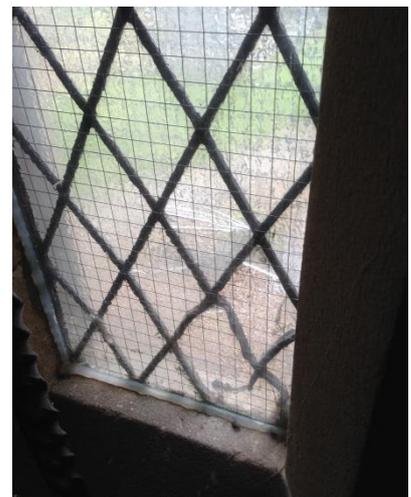
The two lights in the vestry (north transept) east window have a number of defects. As well as hairline cracks and rusting ironwork, noted in the previous report, one has been smashed and wired glass fitted inside. This is reasonable as a temporary repair, but the window needs re-leading, and the metalwork needs rubbing down and painting. One this has been done, more substantial protection should be fitted outside.

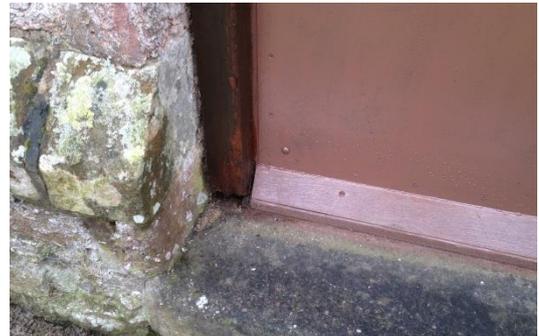
The other external door, to the vestry, has been fitted with a metal plate to make it more secure. This door is in reasonable condition, but there is some rot in the base of the door frame, which needs repairing.

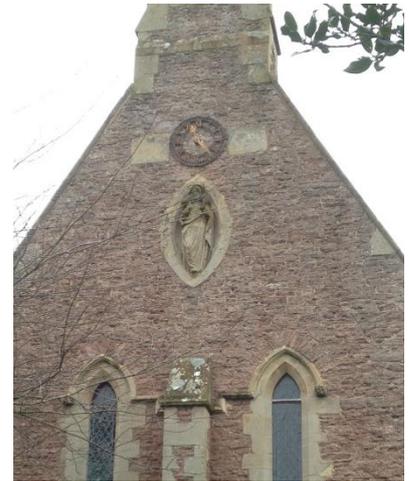
As noted in previous reports, the 'Good Shepherd' carved statue in the west gable end has suffered some erosion, and the surface is shaling. It would be worth accessing this, when carrying out work on the west end masonry (or clock), to assess its condition and removing loose skins. Some further repair or conservation work may be advisable, depending what is found.

The clock is housed internally in boxing at the west end, with the clock face on the outside of the west gable, just above the Good Shepherd sculpture. This is now quite weathered and it would be worth painting and gilding the dial and hands when work is carried out to the masonry.

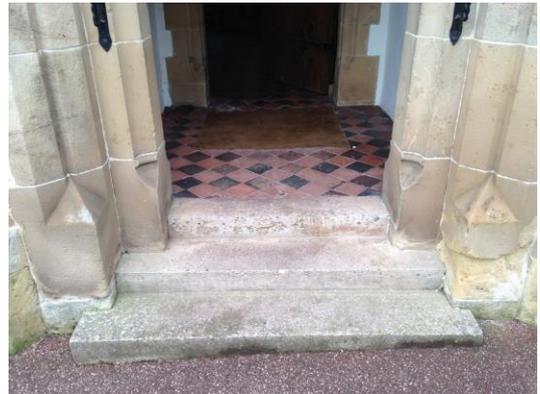
There are three steps into the south porch, with grab rails to both sides to aid access. Although there is a ramp available, the steps are a significant barrier to wheelchair access, and thought is currently been given to the possibility of forming a new entrance, with level access, on the north side.
